STORM WATER PIPE SOLUTIONS

Executive Summary

Landfall Lake is approximately 14 acres of Class III high quality wetland, designed to provide flood protection, wildlife habitat, water quality and recreation. Surrounding the lake is a concrete multi-use pathway.

A recent deposition study was completed by Landfall COA, identifying numerous pipe segments that had been covered up with sediment and vegetative mat. Storm Water Pipe Solutions was tasked to identify and perform selective maintenance on restricted storm water pipes around Landfall Lake.

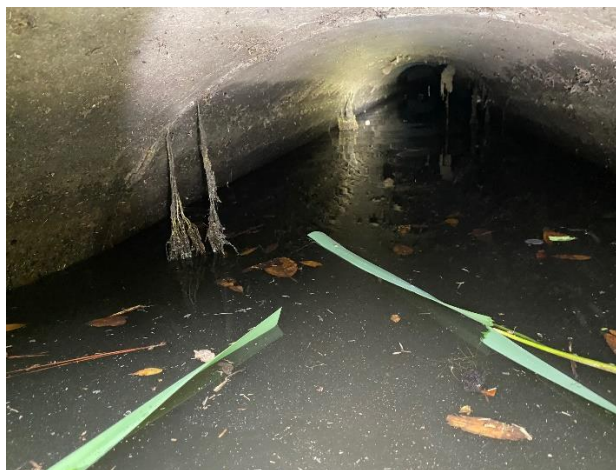
Pipe ID **VW2_VW3** is a 48" reinforced concrete pipe with a flared end section. The outfall drains surface water from parts of Arboretum Drive and Spanish Wells Drive. The pipe holds approximately a half of pipe of water, which is common for coastal community storm water infrastructure. The pipe appears to be free and clear of any obstructions. Picture below is taken at the pipe outfall into Landfall Lake.

Action Taken: None

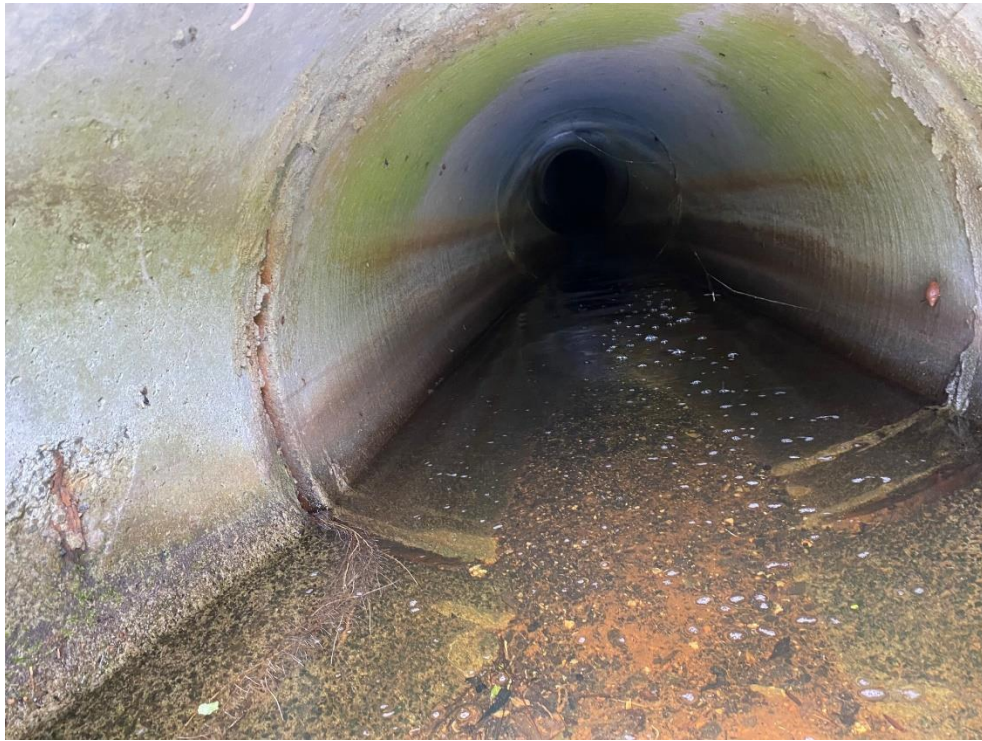
Pipe ID **E15_D16** is a 30" reinforced concrete pipe with a flared end section. The outfall drains surface water from parts of Arboretum Drive, Deer Island Lane and Moreland Drive. The pipe holds very little water and is free and clear of any obstructions. Picture below is taken at the pipe outlet into Landfall Lake.

Action Taken: None

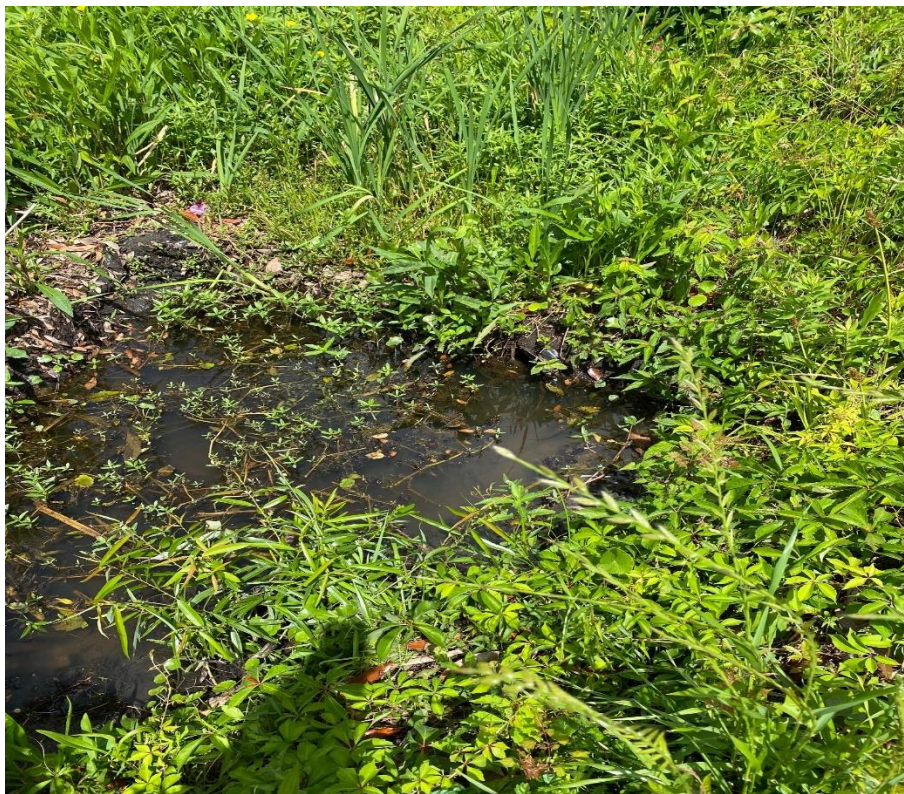
Pipe ID **BP6_BP7** is a 24" double wall corrugated plastic pipe. The outlet drains surface water from parts of Boatswain Place and Turnberry Lane. This pipe is completely underwater, which is common for Landfall, as well as coastal community storm water infrastructure. The outlet has a small sumped pool. When a rain event occurs, hydraulic head pressure builds, forcing water out of the mouth of the pipe. Storm Water Pipe Solutions cleaned and evaluated the internal condition of this pipe in 2017.

Action taken: May 2022: Over excavated the sumped pool to provide additional storage for organic material.

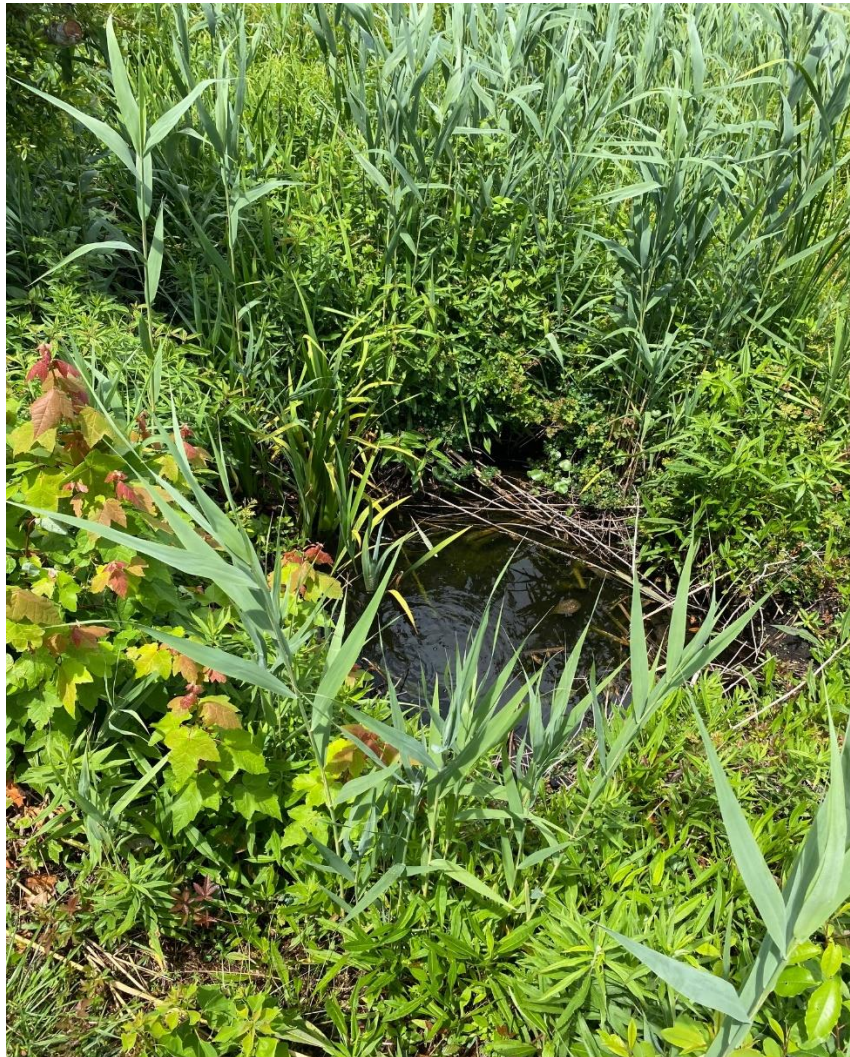
Pipe ID **HWD1_HWD2** is an 18" reinforced concrete pipe. The outlet drains surface water from parts of Turnberry Lane and Harborway Drive. This pipe is completely underwater, which is common for Landfall, as well as coastal community storm water infrastructure. The outlet has a small sumped pool. When a rain event occurs, hydraulic head pressure builds, forcing water out of the mouth of the pipe. Storm Water Pipe Solutions cleaned and evaluated the internal condition of this pipe in 2021

Action taken: May 2022: Over excavated the sumped pool to provide additional storage for organic material.

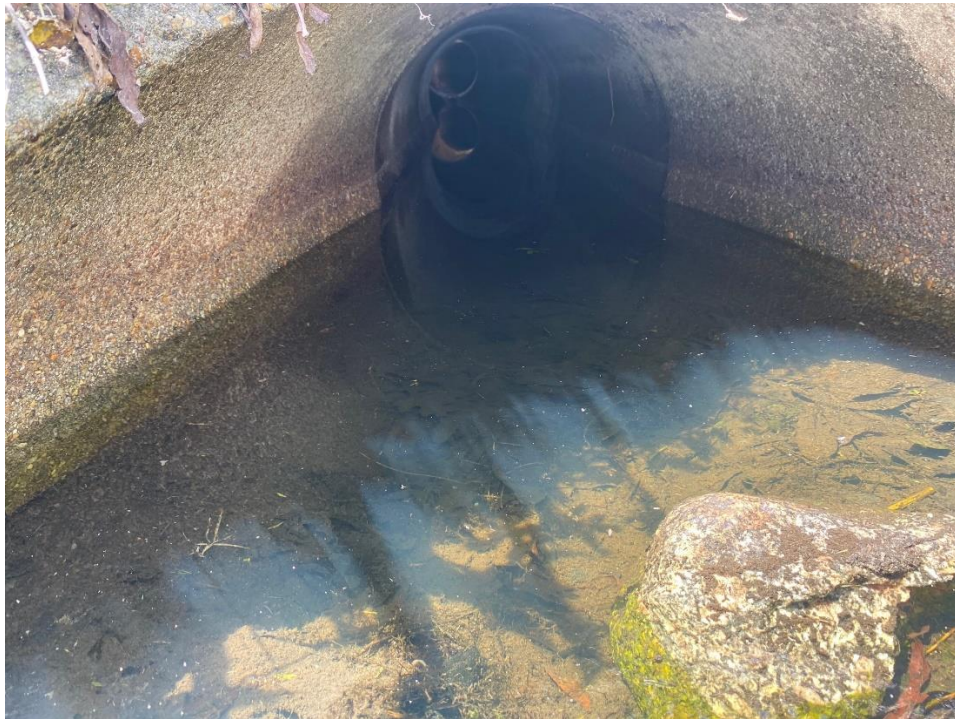
Pipe ID **AD3_Outfall** is a 15" reinforced concrete pipe with flared end section. The outfall drains surface water from parts of Anson Drive. The pipe holds very little water and is free and clear of any obstructions. Picture below is taken at the pipe outfall into Landfall Lake.

Action taken: May 2022: Outlet was excavated at the flared end section, and a tail ditch was created to efficiently convey surface water with minimal disturbance.

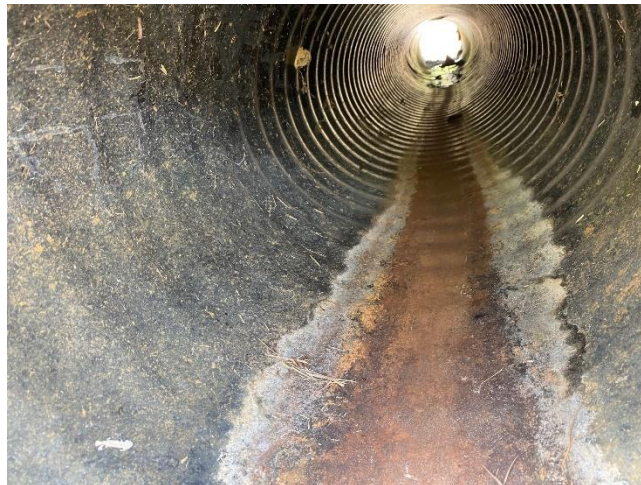
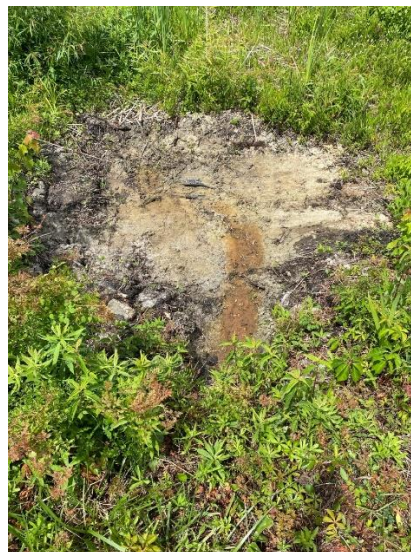
Nineteen other pipes were identified as being standard length, width and slope. These pipes were installed as part of the multi-use path and convey surface water from one side to the other. The pipe material is double wall corrugated plastic pipe, approximately 20' in length with flared end sections at both ends. Pictures shown below are a representative sample of work performed.

Action Taken: 15 of the 19 pipes identified had vegetative mat and deposition, restricting the outfall.
May 2022: Outfalls were excavated at the flared end section and a tail ditch created to efficiently convey surface water with minimal disturbance.

All pipes around the lake are functioning as intended. Disturbed areas will naturally revegetate over the course of a growing season. Storm Water Pipe Solutions recommends that the area be re-evaluated every 3-5 years or after a major weather event.
