1177 Arboretum Drive

Form 3 - Window Replacement Submittal Detail

June 14, 2026

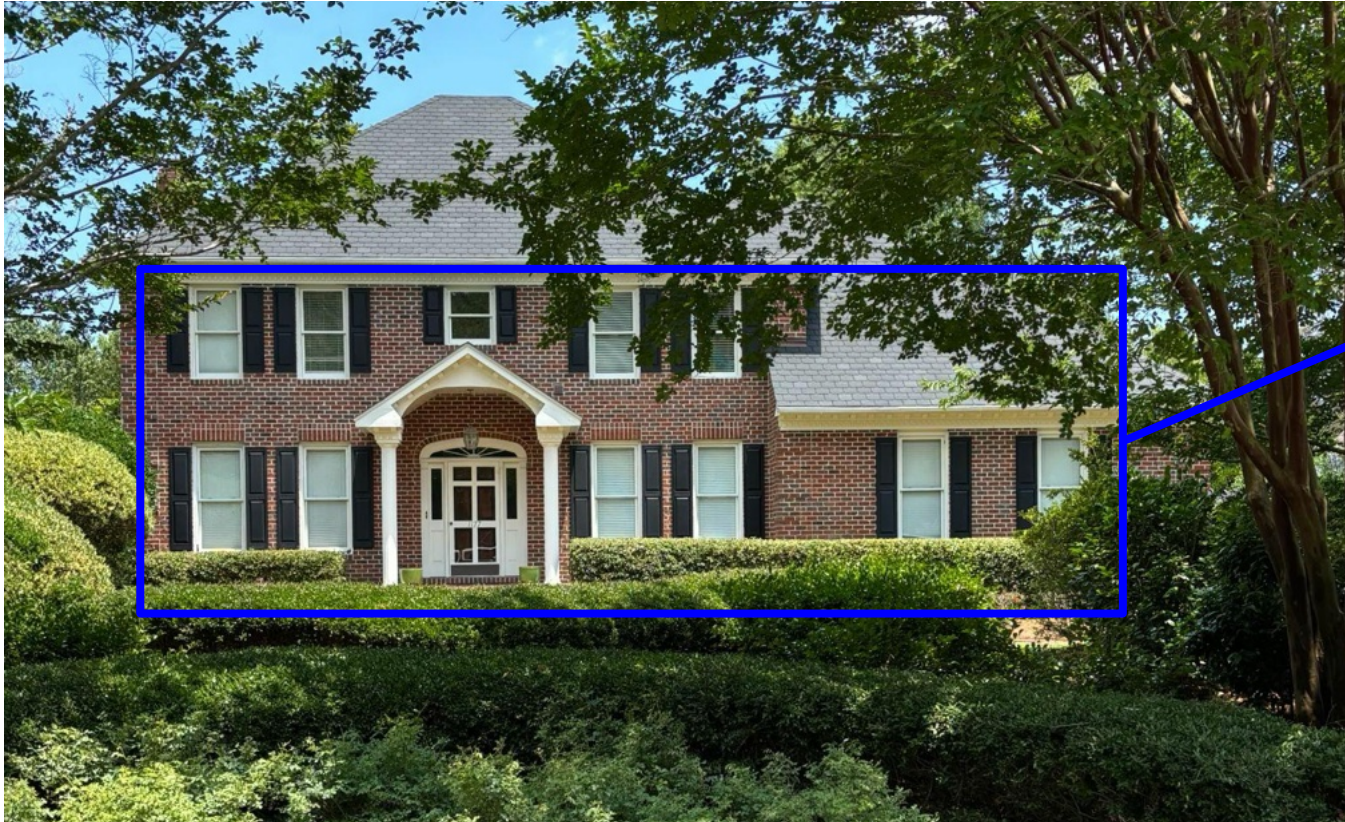
Front Elevation (West)

All 11 windows to be
Double Hung 6-over-6
exterior SDL grilles

Goal: Preserves a cohesive Colonial fenestration pattern across all street-visible elevations, meeting ARC Guidelines 3.3.2, 3.3.3, and 3.3.4.

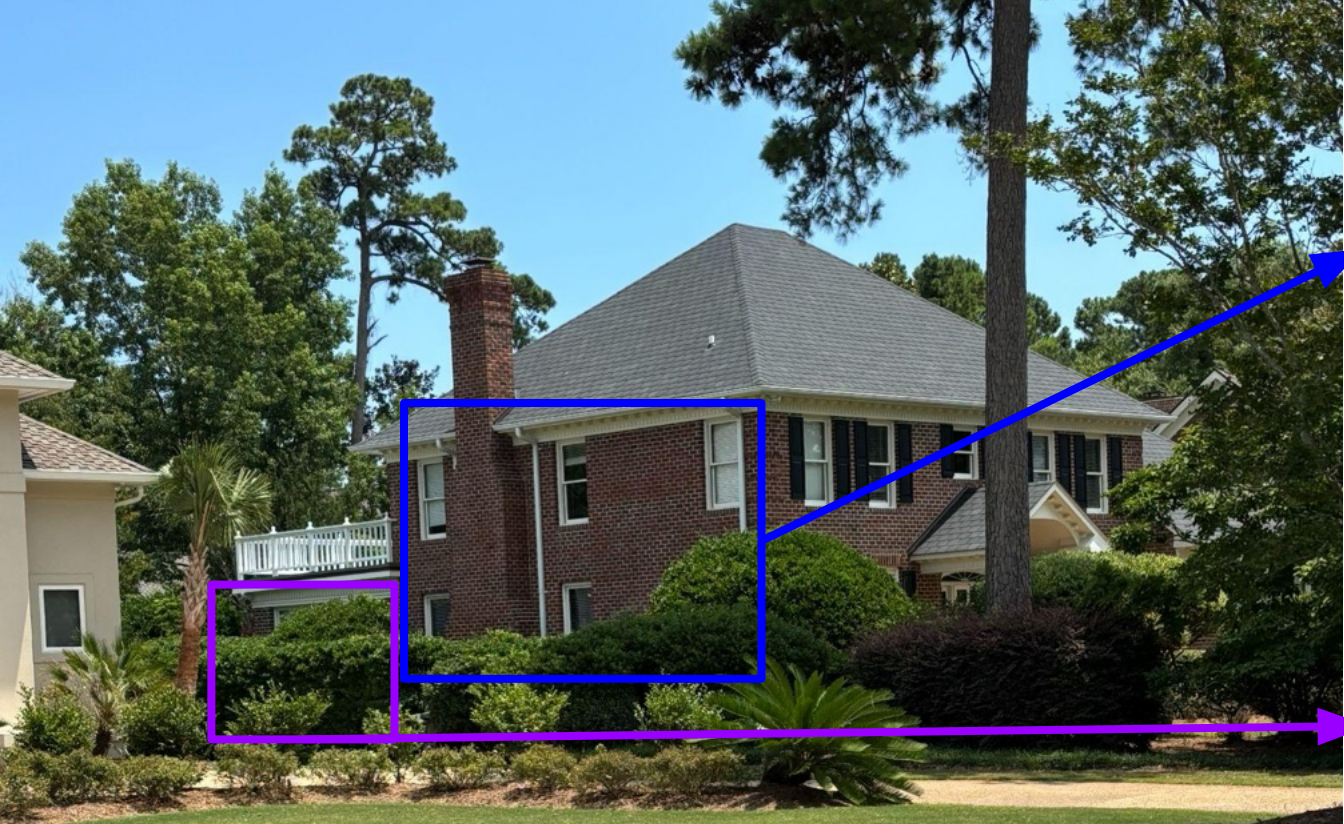
Left Elevation (North)

6 windows to be Double Hung 6-over-6 exterior SDL grilles

4 sunroom windows to be Double Hung Clear (to preserve consistency in room that's not visible from street).

Goal: Preserves a cohesive Colonial fenestration pattern across all visible areas, meeting ARC Guidelines 3.3.2, 3.3.3, and 3.3.4 while maintaining consistency in the sunroom. Natural transition from divided lites on all visible areas to clear glass on the rear elevation due to year-round evergreen

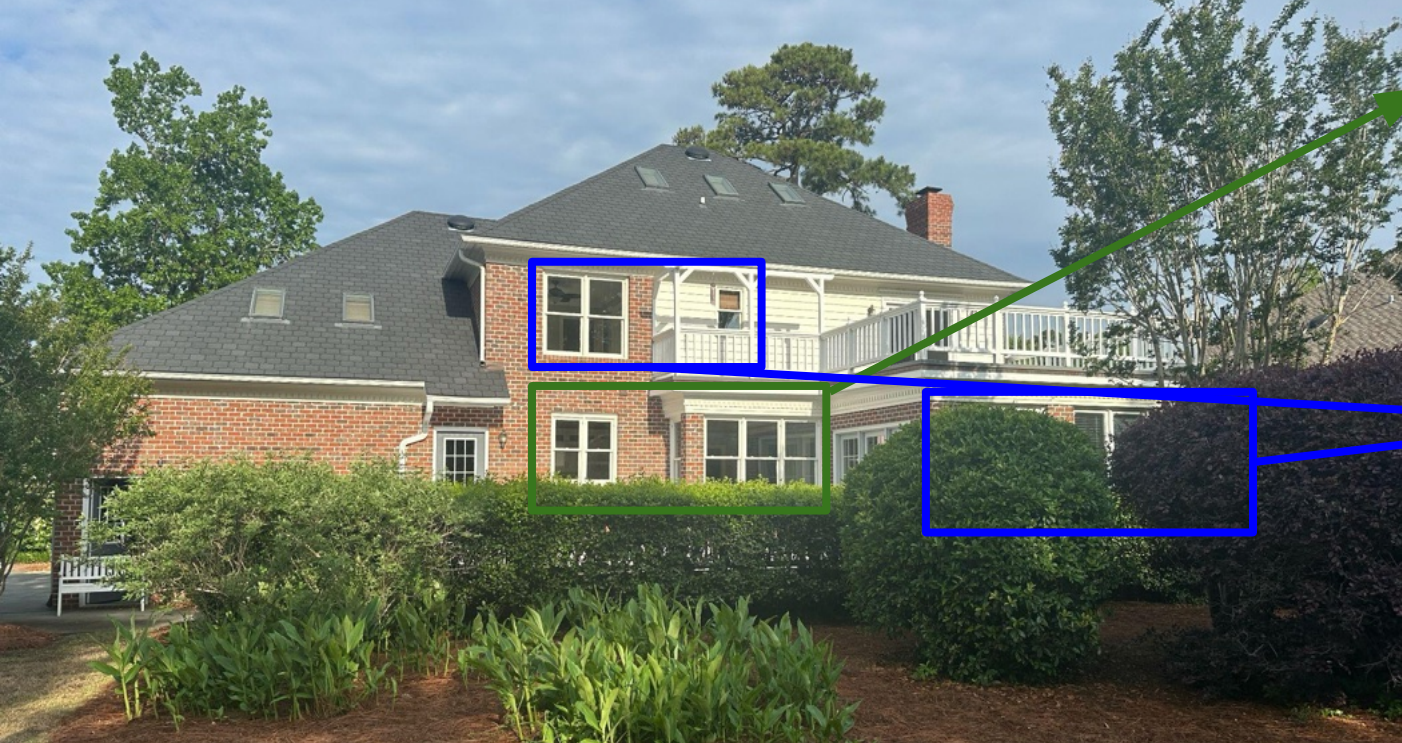
Rear Elevation (East)

6 total new casement windows at kitchen

7 windows to be Double Hung Clear (to preserve consistency in elevation that's not visible from the street, neighbors, or golf course).

Goal: Meet ARC Guidelines 3.3.2, 3.3.3, & 3.3.4. Preserve consistency with existing clear glass elements (sunroom, sliding doors, and skylights) & casements to establish a clean visual hierarchy, prevent competing sightlines, & establish the existing SDL doors as the primary architectural anchor for this elevation. This configuration intentionally opens the home to the private backyard environment where, per Guideline 3.3.3 #2, this “particular elevation is not visible from the street, neighbors or golf course”.

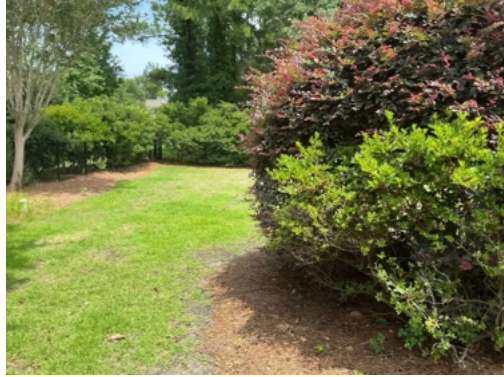
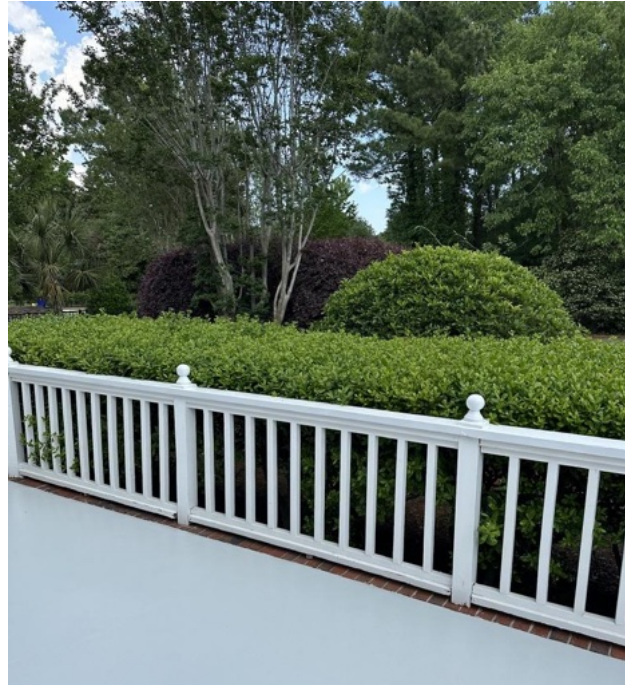
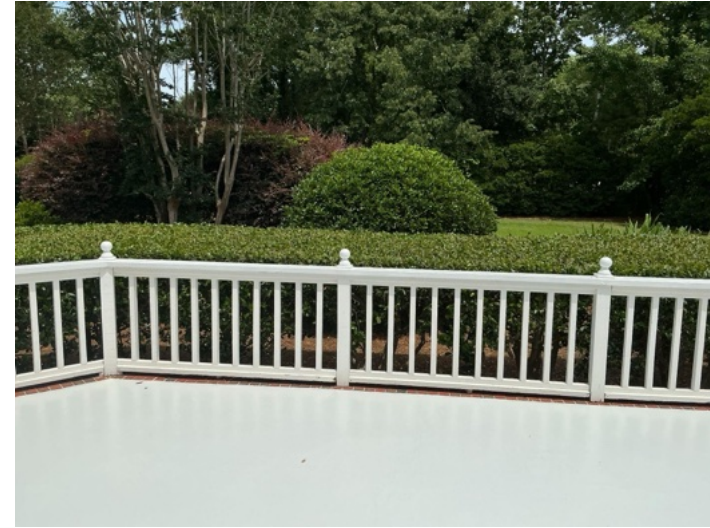
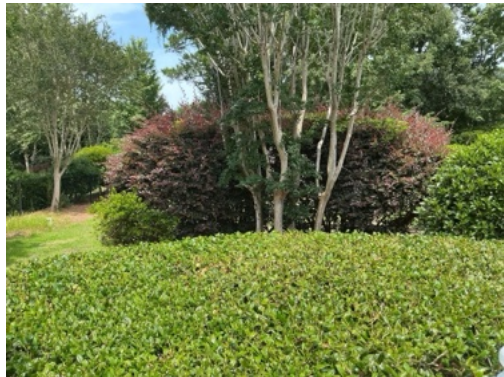
View From Rear Elevation (East)

Per 3.3.3 #2, this “particular elevation is not visible from the street, neighbors or golf course”.

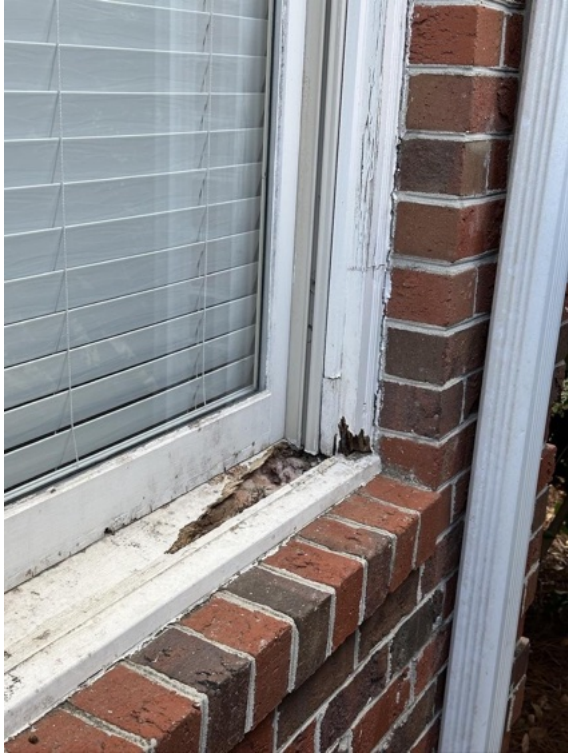
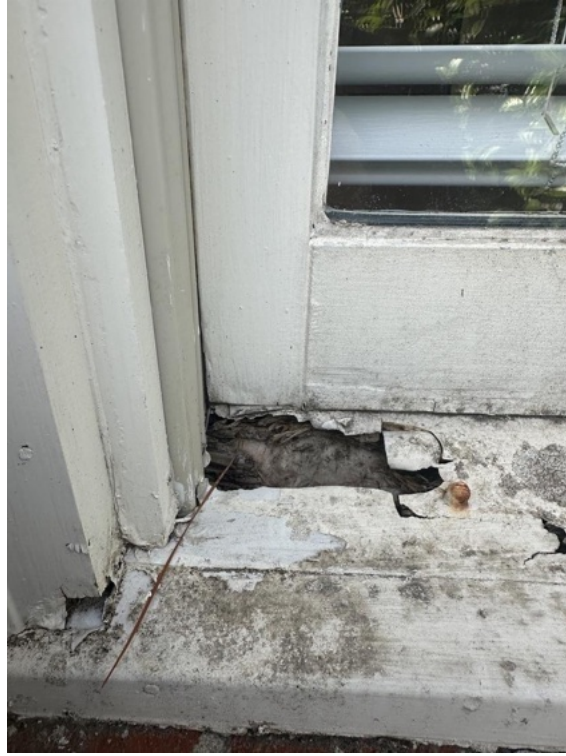
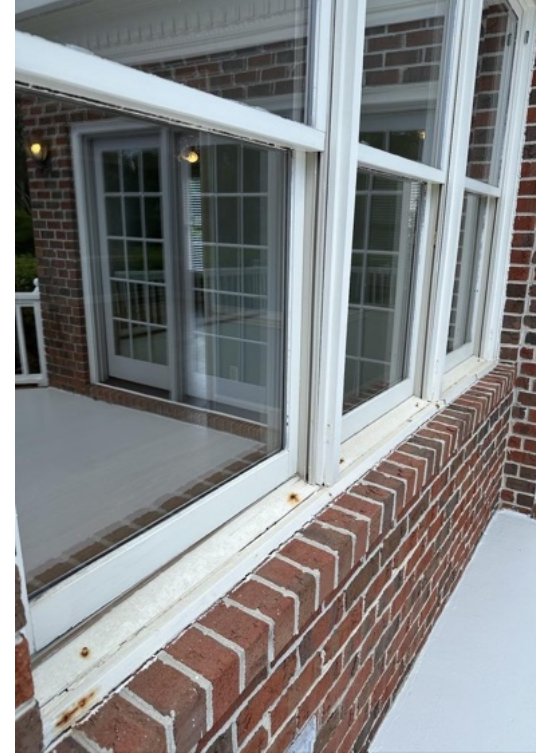
Appendix - Current Window Condition

Note: Typical condition throughout. Lender required repairs.
